Minerals Inspection Report

Mine Name: Morgan Facility	Permit Number: M/029/0008	Mine Status: Active
Operator Name: Geneva Rock Products, Inc.	Inspection Date: 07/31/2013	Permit Fees: Paid
Inspector(s): L. Heppler	Inspection Time: 12:30 PM	Bond Amount: \$450,000
Attendee(s): none	Weather: Sunny, Dry	Bond Escalation: 04/04/2015
Inspection Purpose: Routine annual inspection		Prior Inspection: 11/30/2010

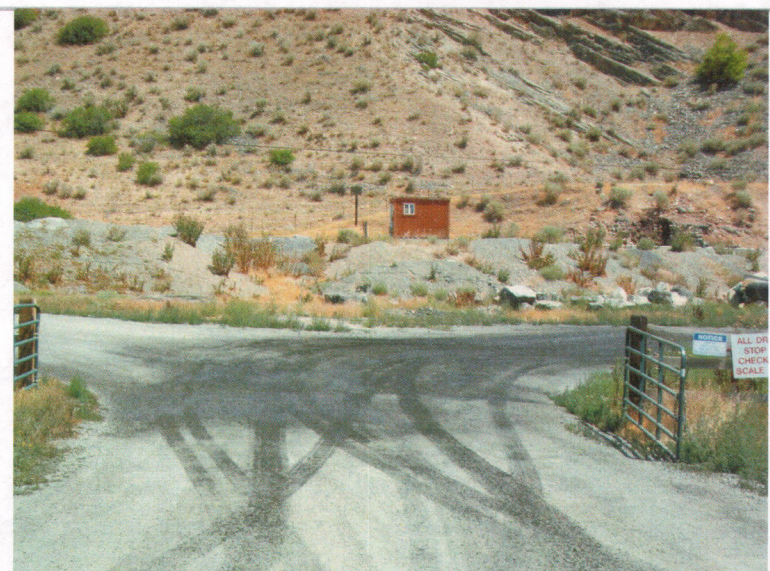
Gate

2. <i>Public Safety (shafts, adits, trash, signs, highwalls)</i> Project is gated, but highwall is significant, original highwall was oversteepened and will need to be fixed prior to closure.	<input checked="" type="checkbox"/>	<input type="checkbox"/>

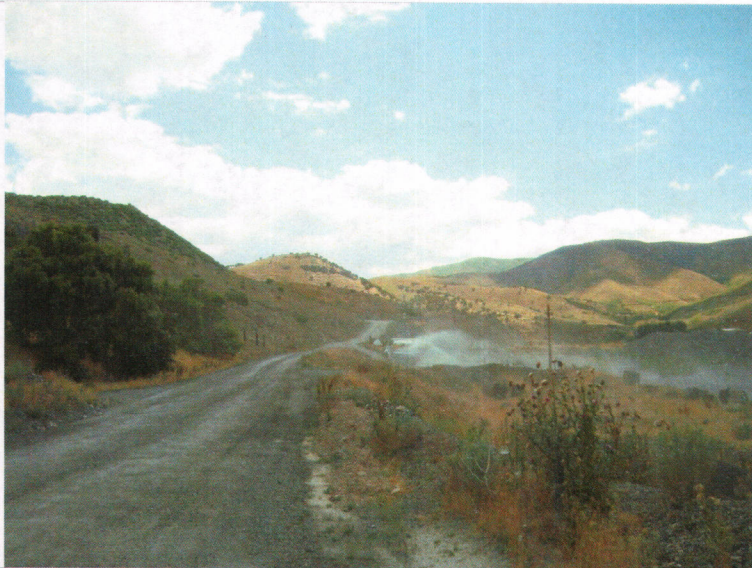
4. <i>Deleterious Material</i> Fuel storage needs to be updated	<input checked="" type="checkbox"/>	<input type="checkbox"/>
5. <i>Roads (maintenance, surfacing, dust control, safety)</i> Roads were maintained and in good condition - see attached photos.	<input checked="" type="checkbox"/>	<input type="checkbox"/>

Road maintained with water

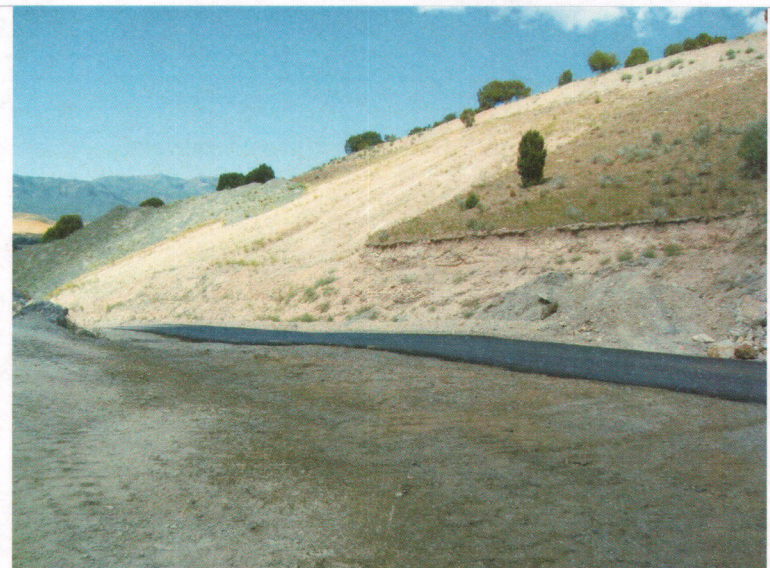
Road with asphalt pavement

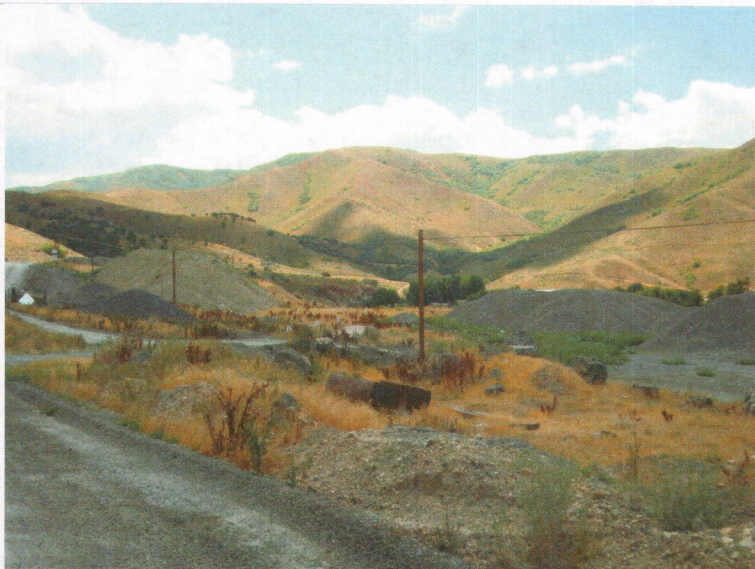
8. <i>Soils</i> Possible soil stockpiles at the base of the hill.	<input checked="" type="checkbox"/>	<input type="checkbox"/>
9. <i>Revegetation</i> No site revegetation has been started.	<input checked="" type="checkbox"/>	<input type="checkbox"/>

Product stockpiles - note topsoil stockpile in background

The Operator needs to stockpile topsoil, implement storm water runoff sediment ponds, both on a regular basis. OGM to continue annual inspections and monitor the site when in the area.
